COLLINS RADIO COMPANY

#### 30S-1 RF LINEAR AMPLIFIER

#### SERVICE BULLETIN NO 2

#### PREVENT INTERMITTENT DROPOUT OF PLATE OVERLOAD RELAY

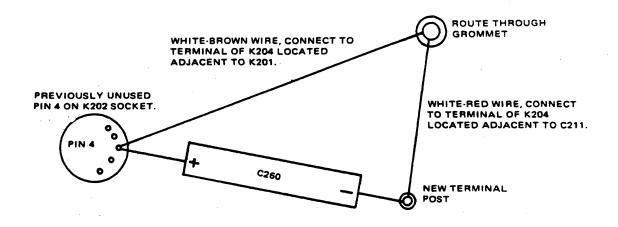
30S-1 Relay Shelf, Underside, Modification Instructions

Some 30S-1 operators experience occasional dropout of plate overload relay K204, caused by short duration high plate currents. These currents sometimes occur after application of signal but before the exciter output is reduced by the alc circuits. A  $2000-\mu F$ , 6-volt dc capacitor installed across the energizing coil of the relay presents a low-impedance path to the audio envelope currents, but continues to provide dc overload protection. The instantaneous currents are not harmful to the 4CX1000A tube because of conservative tube operation.

3. Install 2000- $\mu$ F capacitor C260 (183-1311-000) and approximate 10-inch lengths of white-brown (439-7302-000) and white-red (439-7303-000) wires as shown in the illustration.
