COLLINS RADIO COMPANY

30S-1 RF LINEAR AMPLIFIER

SERVICE BULLETIN NO 3

REDUCE EXCESSIVE ALC CONTROL

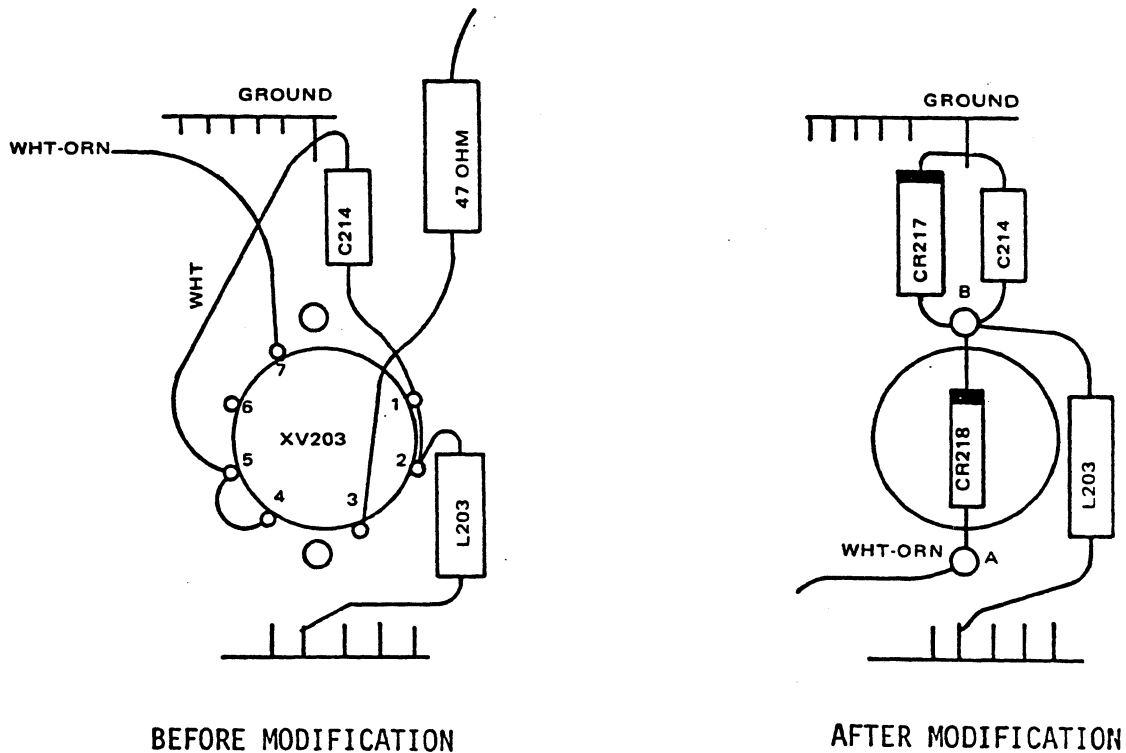
30S-1 SB 3 Modification, Components -- Wiring Locations
Figure 1

30S-1 units originally employed a 12AL5 dual-diode as the alc rectifier, V203. Some production runs of this tube exhibited high space-charge characteristics resulting in objectionable high standoff voltage on the alc line. The method recommended to ensure proper alc operating voltage is to substitute 1N457 silicon diodes for the tube.

NOTE: Refer to figure 1 for component and wiring locations in following steps.

3. Remove and discard white wire from XV203 pins 4 and 5 to terminal strip ground.
4. Remove securing hardware and lift socket XV203 out of the way.
5. Install two terminals A and B (306-0234-000) in removed XV203 socket mounting holes with screws (343-0285-000) and washers (373-8010-000).
6. Disconnect white-orange wire (from J202) at XV203-7 and reconnect it to terminal A.
7. Disconnect L203 lead from XV203-2 and reconnect to terminal B.
8. Disconnect C214 lead from XV203-1 and reconnect to terminal B. Discard XV203 that is now free of circuit.
9. Install 1N457 diode CR218 (353-0204-000) from terminal A to terminal B (banded end).
10. Install 1N457 diode CR217 (353-0204-000) from terminal B to terminal strip ground (banded end).
